Manhole Inspection Summary

Manhole # S33AA1007MH

Insp Date: **3/5/07 4:07 PM**

Location Address: **3327 SAINT PAUL ST**

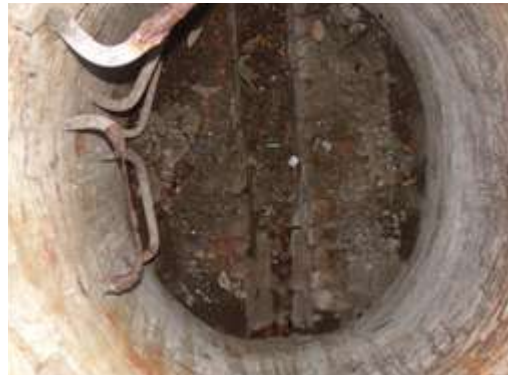
Top View

Corroded and missing steps. Bench and Channel debris.

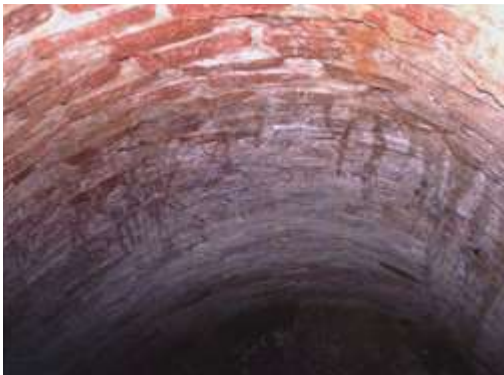
Defect

Adjustment, Corbel, and Barrel infiltration.

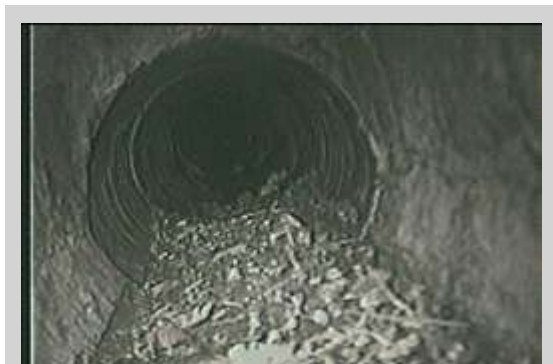
Pipe Out @ 12 O'Clock

Rod and Bar (Angled)

Deposits: ☐ None ☒ **Mud** ☐ Sludge ☒ **Debris** ☐ Grease

Infiltration: **Evidence** Pipe Seal Cond: **Cracked**

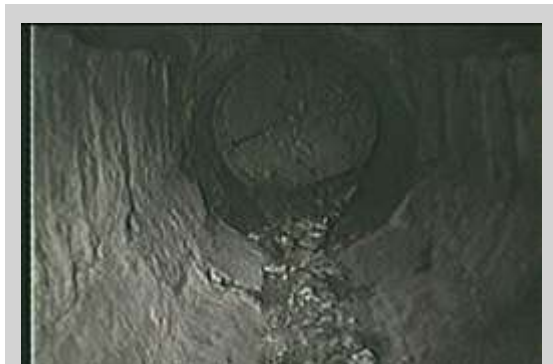
Pipe In @ 6 O'Clock

Plugged.
